MINNESOTA SPORTS FACILITIES AUTHORITY MEETING AGENDA

March 31, 2023, 8:00 A.M.

**U.S. Bank Stadium – Mystic Lake’s Club Purple
401 Chicago Avenue, Minneapolis, MN 55415**

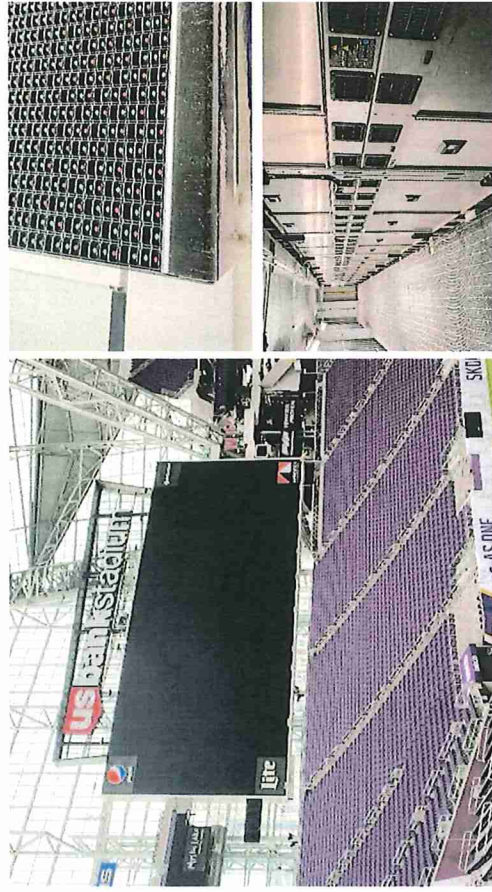
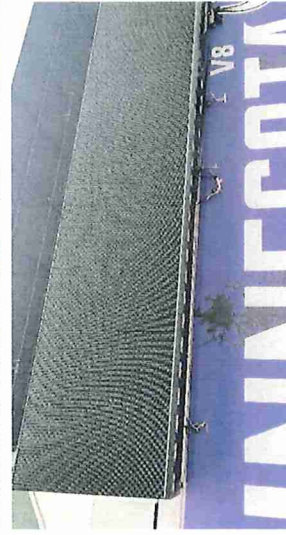
- + Location: Stadium Bowl
- + Subject: LED Displays
- + Condition - Good: Primary LED displays have been well maintained. Based on the age of the displays, anticipate replacement starting in 4-6 years. We recommend moving from a through-hole technology to surface-mounted diode (SMD) technology. The current trend is leaning toward 10mm pixel pitch.

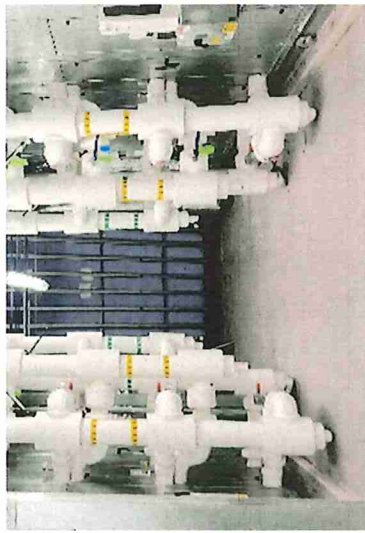
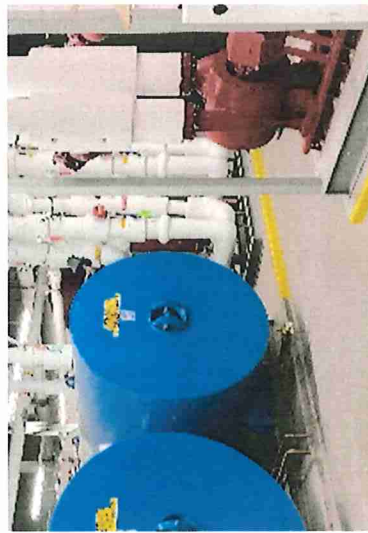
- + Location: Multi-Level
- + Subject: Steam and Hydronic Systems
- + Condition - Good: Steam and hydronic systems throughout the stadium remain in excellent condition. Glycol concentration has been maintained and regular water testing is provided. The gutter snowmelt system is maintaining operation and shows no signs of failure. An overall water balance of all air handling systems is recommended at this time. This can be limited to air handling units only, and not extended to terminal units. As part of the overall water balance, all air handling unit valves should be tested and adjusted for proper flow and control.

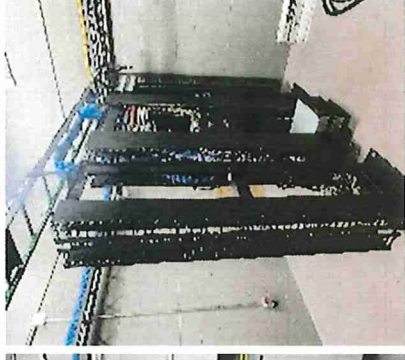
- + Location: Multi-Level
- + Subject: IDF Rooms
- + Condition - Good: IDF's throughout the facility are nowhere near capacity. With ample room available the stadium is in a good position to expand technology services. IDF 4D2 is reaching capacity in its current state. A new 2 post rack may need to be installed or a reconfigure of the current layout could be required.

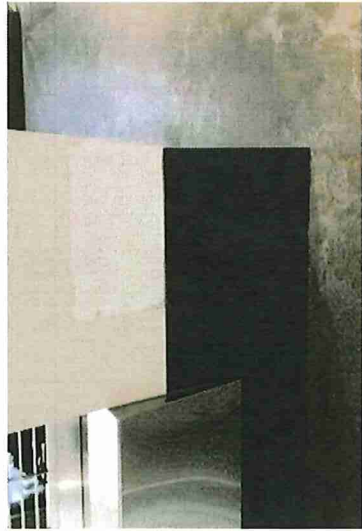
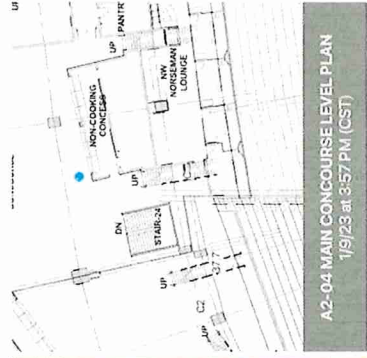
- + Location: Main Concourse / Service Corridor
- + Subject: Interiors - Walls & Paint
- + Condition - Fair: Repair damage to walls and touch up paint.

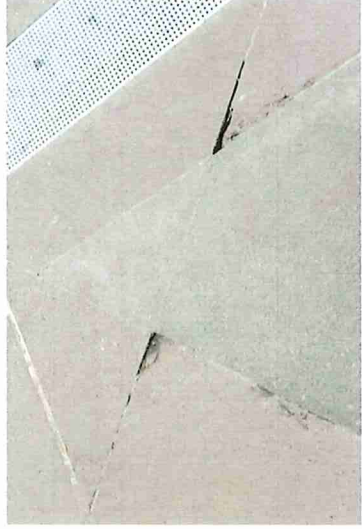
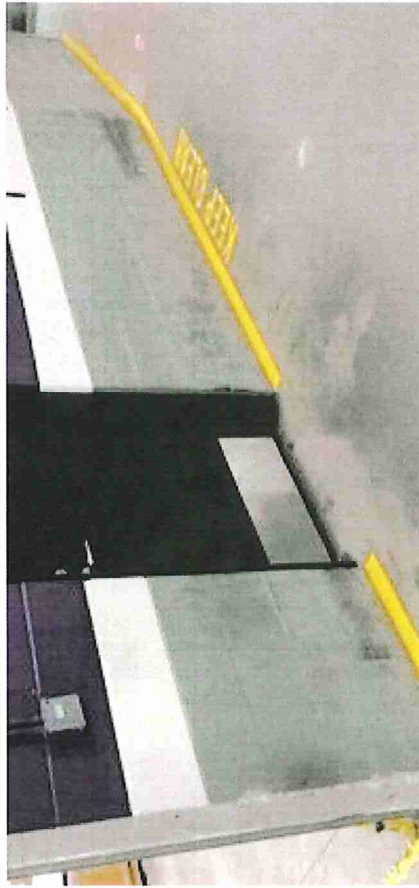
- + Location: Site - East Plaza
- + Subject: Hardscape
- + Condition - Fair: Missing chunk of concrete in walk.

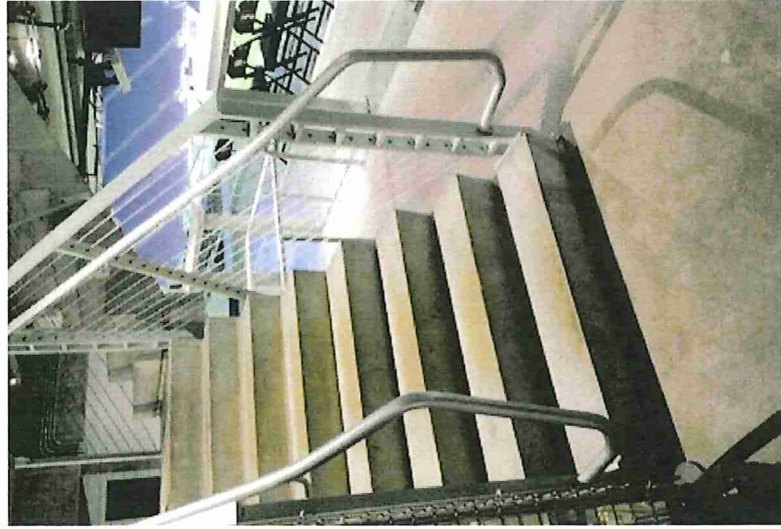
- + Location: Concourse - Southeast, Redzone
- + Subject: Handrails
- + Condition - Fair: Bent and possibly encroaching on egress width. Review for code compliance.

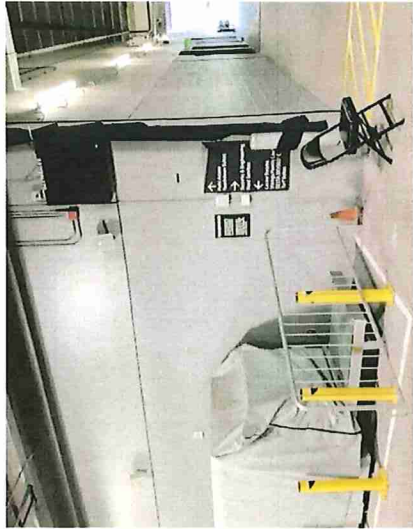
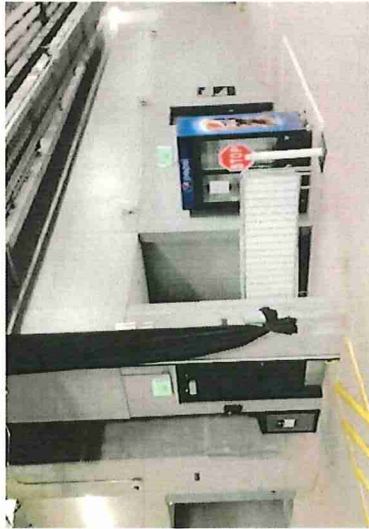
- + Location: Event Level - Service Corridor
- + Subject: Wayfinding Signage
- + Condition - Fair: Move wayfinding signage to wall above storage. Many signs in Event Level are too low and will get blocked by storage of items for events.

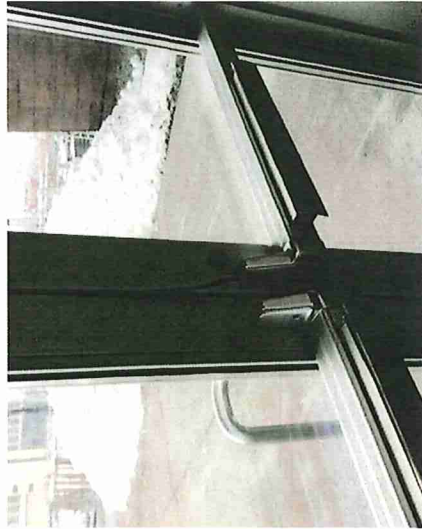
- + Location: Exterior Envelope
- + Subject: Storefront Entry
- + Condition - Worn: Damaged weatherstripping creating openings to exterior.

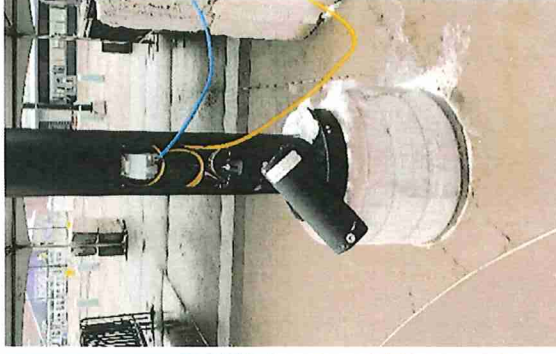
- + Location: Site - West Plaza
- + Subject: Electrical Equipment
- + Condition - Worn: The Hoffman enclosure has been damaged which may be the result to a loss of connectivity in the Plaza. West Plaza power is being used for setup/security purposes. Recommend using the in-use covers which allow for the cord be fed through the bottom of the cover.

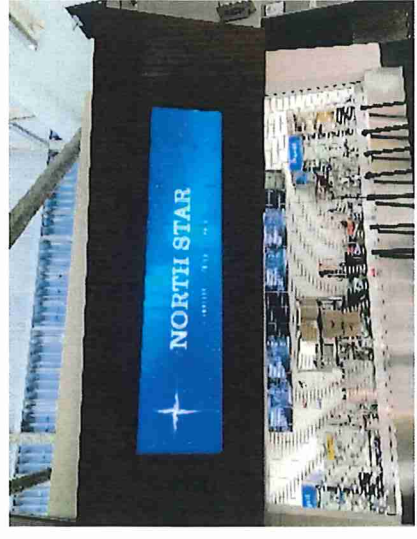
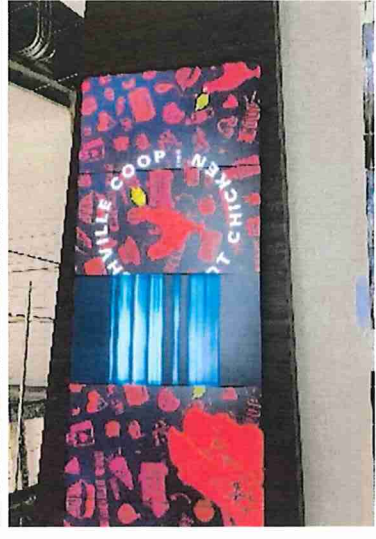
- + Location: Concourses
- + Subject: Concession Displays
- + Condition - Worn: Vertical concession displays are starting to fail with no backups onsite. Display model is no longer manufactured. Look to replace main concourse with new fine pitch LED and use remaining functional displays for replacement parts for the upper concourse.
